# Intel<sup>®</sup> Celeron<sup>®</sup> Processor Specification Update

Release Date: May 2002

Document Number: 243748-045

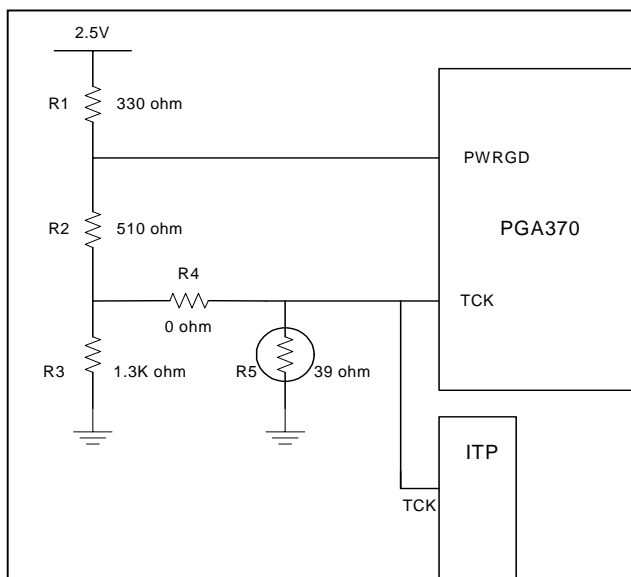
**Figure 1 Celeron® on 0.13 Micron Processor 256K Platforms Workaround**

In addition, the example workaround circuits shown do not support production motherboard test methodologies that require the use of the processor JTAG/TAP port. Alternative workaround solutions must be found if such test capability is required.

For Production Boards:  
*Depopulate R5*

To use ITP:  
*Install R5, Depopulate R4*
